Technical Memorandum

To: Paul Beaulieu, Trout Unlimited
From: Brian Graber, Staff Scientist, Massachusetts Riverways Program
CC: Todd Richards, Division of Fisheries & Wildlife
Terry Connolly, Trout Unlimited
Date: November 8, 2004
Re: Swift River Habitat Rehabilitation: Rock Structure Removal

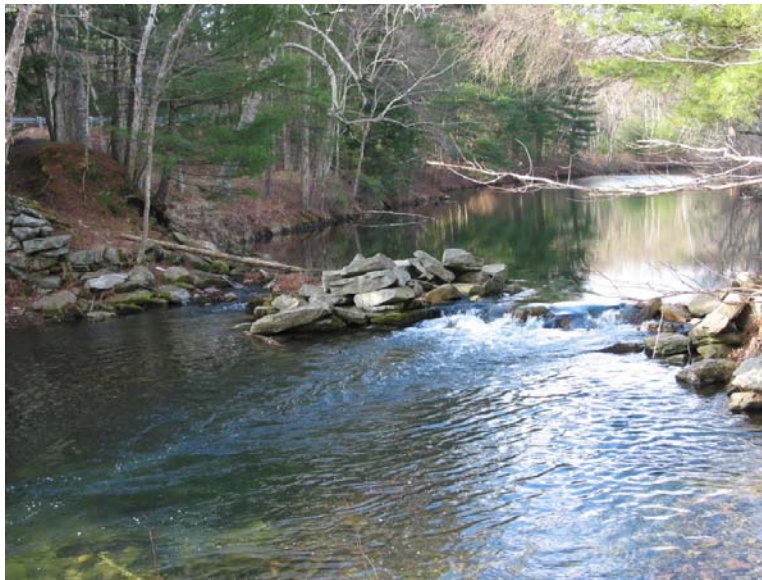
Photo 1. Rock structure constricting flow in the Swift River downstream of the Route 9 Bridge. Photo by Paul Beaulieu.

- Note the drop in the water surface over the rock structure. This indicates that the rock structure is acting as a flow constriction and is impounding the flow by an additional depth of 0.8 feet.

1) Lower the rock structure until the upstream water surface matches the downstream water surface.

Operationally, the current lowest point of the rock structure cross section should be lowered approximately 0.8 feet and the rest of the rock that is above this level should be removed while monitoring the change in the water surface.

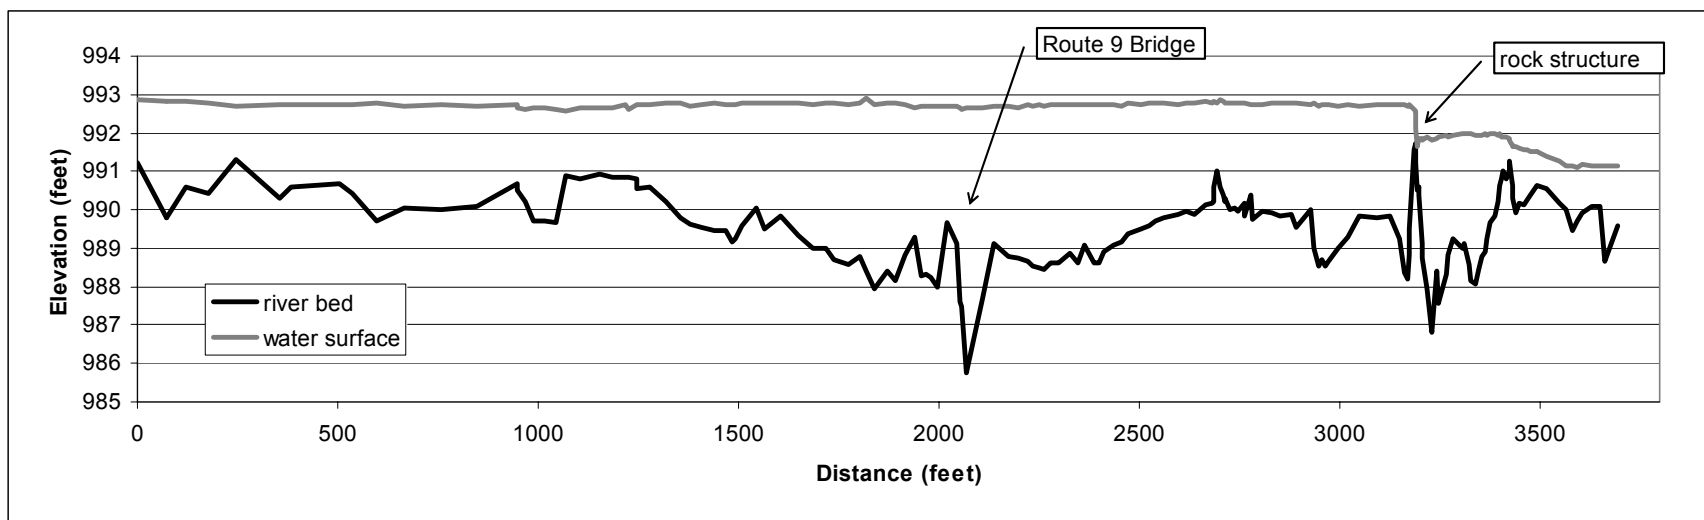
Figure 3. A longitudinal profile showing elevations of the river bed and water surface. The river flow is from left to right. Note the vertical exaggeration – the bed features are longer than they appear on this graph.

- The water surface is remarkably flat upstream of the rock structure for 3,300 feet, with virtually no slope over that distance. This indicates the extremely low energy of this stretch of river.

- Fluctuations in the bed reveal bed features that are covered by the currently impounded water. If the water surface was lower, there might be riffles at distances 250, 1185, and 2695 along the profile.

- Note the riffle downstream of the rock structure beginning at distance 3425. This riffle is approximately 150 feet long and has characteristic shallower water with the water surface sloping downward as it drops in elevation along the riffle. This structure of flat pools and sloped riffles is characteristic of typical pool-riffle sequences found in rivers of this type. There is another similar riffle approximately 100 feet upstream of the upstream end of the longitudinal profile that was not measured.

- There is a deep pool just downstream of the Route 9 Bridge. This is a common feature downstream of bridges as the flow hydraulics through the bridge structure scour out the bed immediately downstream.

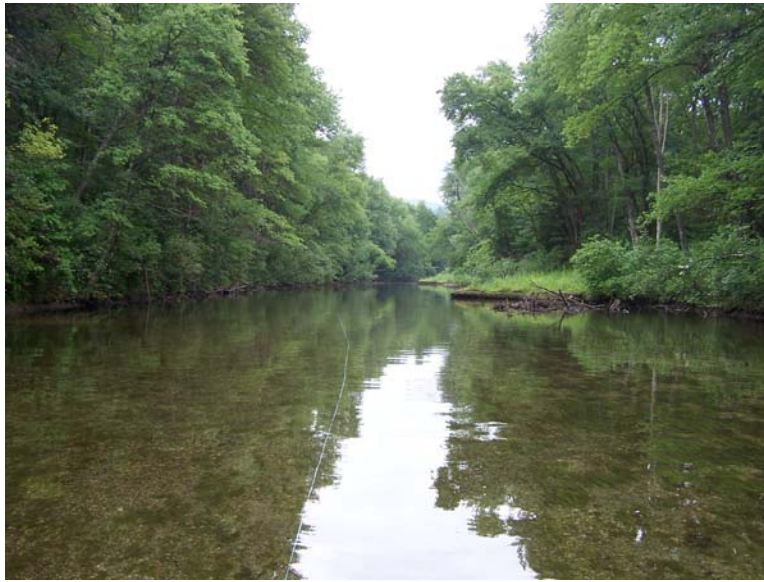
The river is currently a long pool for approximately 3,300 feet upstream of the rock structure and is completely devoid of riffle habitat. Riffles are important habitat features in this type of river because the shallower oxygenated flow through gravels on the bed are suitable for both spawning and macroinvertebrate productivity. Macroinvertebrates are an important food source for other aquatic life in the river.

Photo 2. A stretch of river upstream of the Route 9 Bridge showing the long, flat pool character of the river.

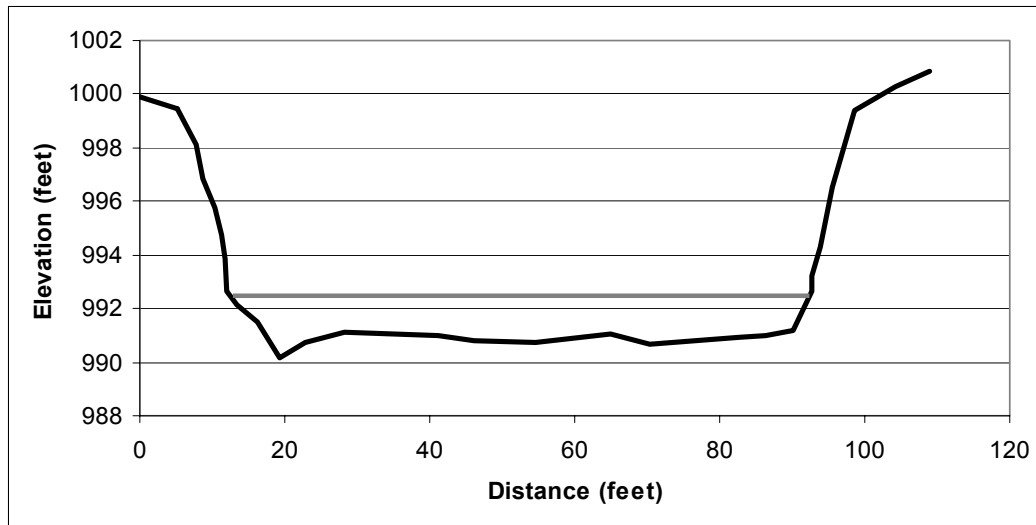
Figure 4 shows a typical cross section measured between the bridge and the rock structure at river distance 2698 on the longitudinal profile. This cross section shows the steep, high banks and the lack of development of a new floodplain surface within the old river banks (see also Photo 3).

Figure 4. A typical channel cross section upstream of the rock structure showing the high, steep banks characteristic of this stretch. This cross section was surveyed at river distance 2698 on the longitudinal profile. The gray line is the water surface.

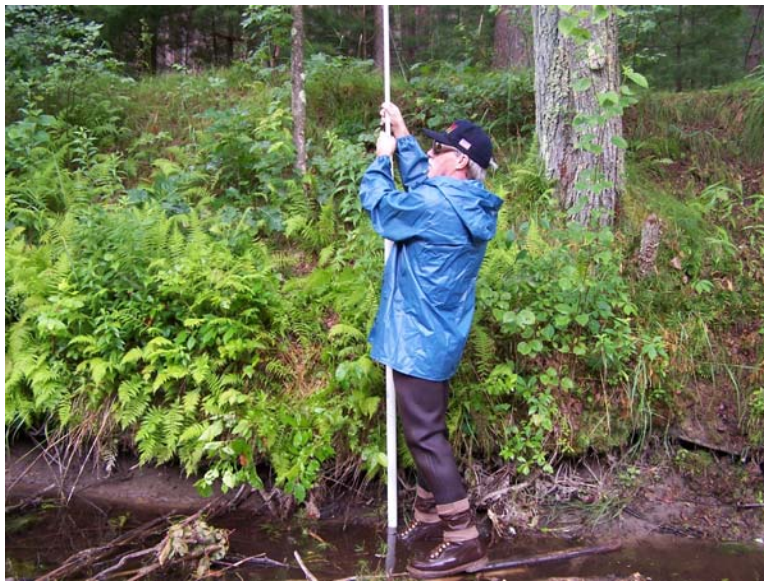
Photo 3. Surveying a cross section of the river upstream of the Route 9 Bridge. Note the flat, former floodplain surface more than six feet above the baseflow water surface.

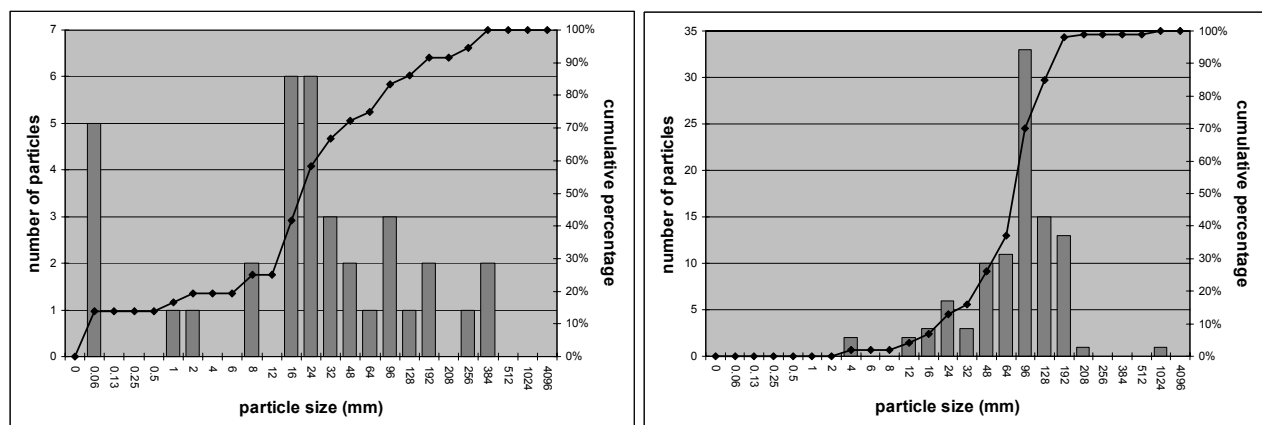
A sample of the bed material approximately 500 feet upstream from the rock structure indicates that there is a solid bed underneath a small quantity of silt (see Figure 5). The longitudinal profile indicates that this portion of the stream may have been a riffle prior to the rock structure. Currently this section includes primarily gravels and cobbles along with the surficial silt. Swifter flowing water could clear out some of the silt material and expose more of a cobble bed, such as in the riffle downstream of the rock structure. Note in Figure 5 that the swifter flow in the downstream riffle creates a tighter distribution of particle sizes and smaller silt particles are flushed away. Note also that along with the channel structure itself, the bed material in the downstream riffle is also sized for a larger river indicating that this is a remnant of the previous channel and flow regime. The cobbles in the riffle were transported and deposited over time by much larger flows than currently occur. The current flow regime would be more likely to transport and deposit smaller gravels.

Figure 5. Bed material samples comparing the bed approximately 500 feet upstream of the rock riffle (left graph) with the bed in the riffle downstream of the rock structure (right graph). The left graph is a spread of gravel and cobble with some silt and the right graph is a tighter distribution centered around cobbles.

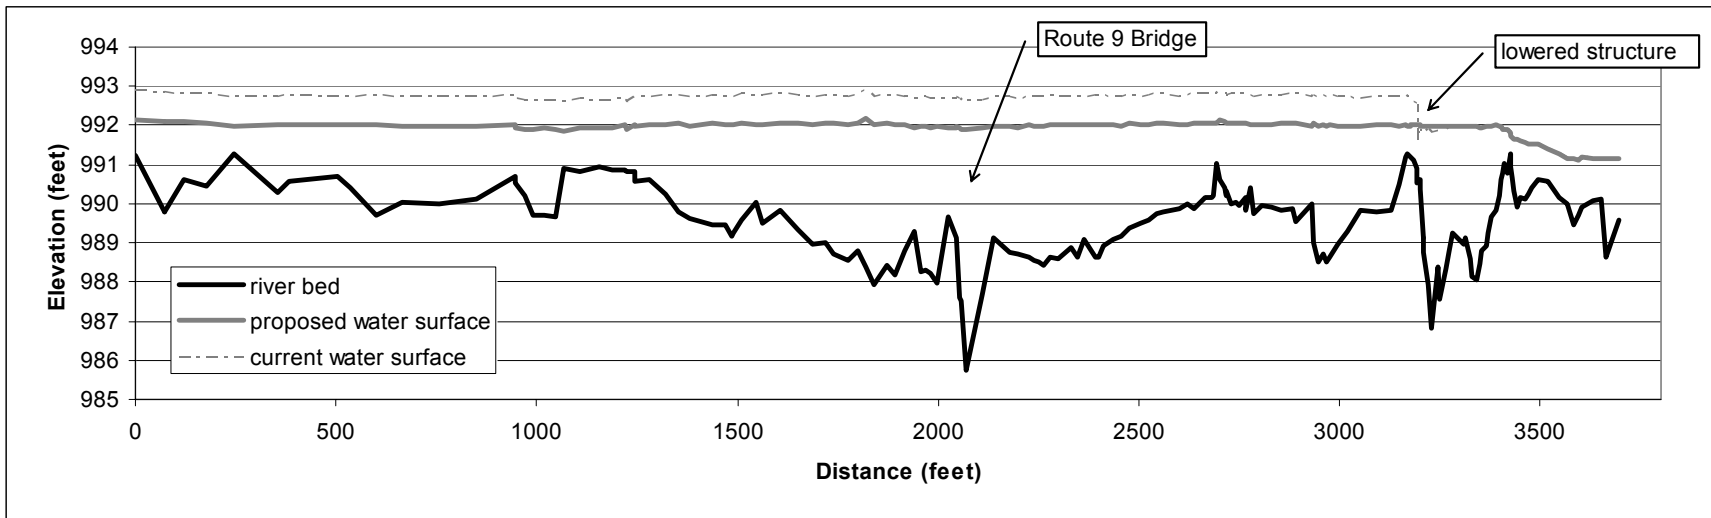
Note on the longitudinal profile that if the rock structure was completely removed, the downstream riffle would now control the upstream water level. The water level cannot go any lower than this downstream riffle. This is known as grade control, and the cobbles in the downstream riffle provide very stable grade control, meaning that the channel will not likely cut downward below that surface. As was mentioned earlier, the cobbles in the downstream riffle are sized from the previous flow regime. Based on an incipient motion analysis, the mean particle size in the downstream riffle will likely not move in a 100-year flood in the current flow regime. Therefore, the rock structure should not be lowered any further than 0.8 feet. Otherwise shallow, excessively high velocity flows will result in the downstream riffle that would not be beneficial.

Figure 6. Longitudinal profile showing the proposed change in the water surface from lowering the rock structure. Note that the downstream riffle starting at distance 3425 will act as grade control after the rock structure is lowered.

Lowering the rock structure will lower the water surface, increase the flow velocity, and beneficially expose some of the channel features between the rock structure and the riffle 3,400 feet upstream. The primary objective is to lower the rock structure so that the water surface lowers the 0.8 feet that will connect it with the downstream water surface. Note that the flow depths in the downstream riffle range around one foot deep (see Figure 3). This indicates that when the water level is brought down by 0.8 feet, some extent of riffles will be uncovered where the flow depth will be near one foot deep. This will include features at river distances 250, 1185, and 2695 along the longitudinal profile (see Figure 6). This reduction in the water level will not significantly affect pool habitat as many deep pools will remain.

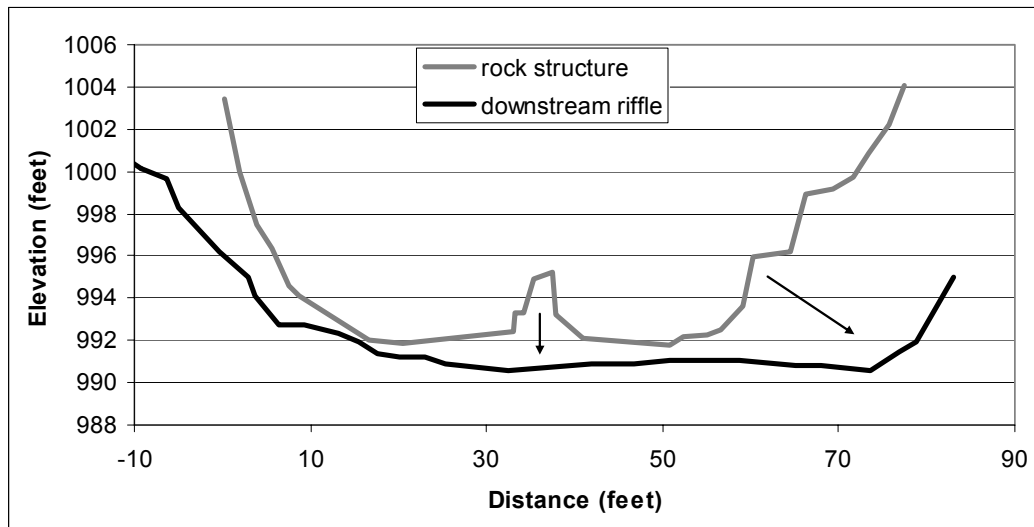
The river at the rock structure is narrower than elsewhere, additionally contributing to the flow constriction that is slowing flow upstream. Therefore, also remove the rock on the sides of the section to widen the cross section to the extent possible to eliminate it as a flow constriction. Figure 7 conceptually shows this by comparing the current rock structure cross section with the cross section of the downstream riffle. Again the ultimate objective is to lower the water surface by 0.8 feet and eliminating the flow constriction will help accomplish this.

Figure 7. Conceptual comparison of the current rock structure cross section with the cross section of the downstream riffle. Rock should be removed from the rock structure to both lower and widen it. Note that the diagrams are showing the cross sections such that the right side is river right while facing in a downstream direction.

Leave just enough rock to provide stability to the steep bank slopes. Alternatively, all the rock could be removed from the channel sides and bioengineering techniques could be used to stabilize the steep banks. The banks near the rock structure are steeper and higher than the surrounding banks upstream and downstream. Additionally, the banks could be pulled back to resemble the surrounding banks more. That approach would be significantly more expensive, but would result in more natural vegetated bank materials and more stable bank slopes.

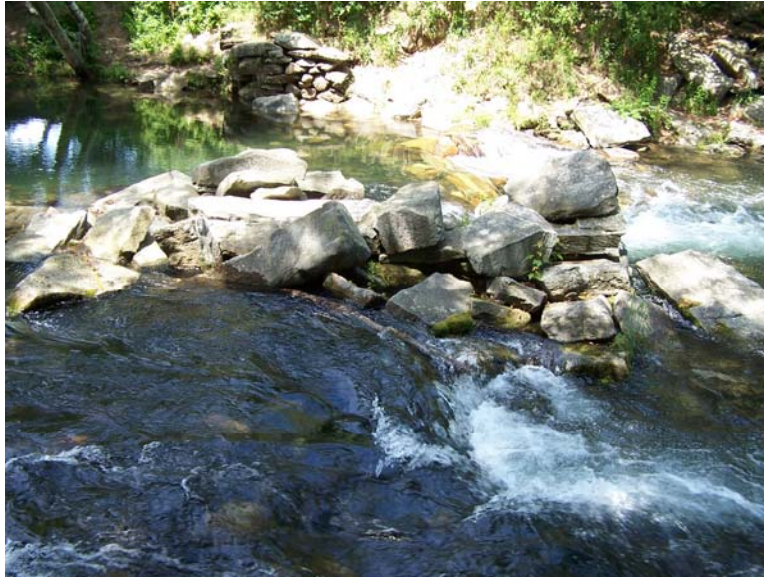
There are currently two ranges of rock sizes in the rock structure (see Photo 4). There are between 65 and 100 large rocks with median axis diameters of 1.7 to 2.9 feet. There are many smaller rocks surrounding these large ones with median axis diameters of 0.7 to 1.2 feet. All of these rocks are large relative to what would normally be found in a riffle in this flow regime, and therefore, they will provide a very stable bed surface. The rock sizes will be too large for optimal spawning sites, but spawning sites may be uncovered upstream when the water surface is lowered. Because of the large rock sizes, the created riffle will be immobile and should be periodically monitored to ensure that any channel changes such as downcutting do not result in the remaining rock obstructing flow again. Alternatively, if the means are available, the rock could be broken to smaller sizes on site.

Photo 4. A close up photo of the rock structure shows the different rock sizes.

As a first priority, use the rock to turn the current rock structure into a riffle. This should be accomplished by spreading the rock in an *upstream* direction from the current structure. By forming the riffle in the upstream direction, the pool-riffle spacing between this riffle and the downstream riffle will be more appropriate.

Ideally, the surface of the riffle should be composed of the smaller rock sizes from the rock structure. This is because larger rocks near the water surface typically scour away smaller particles behind them because of the flow hydraulics, and this scour is undesirable in a riffle. The smaller rock sizes will fit together better to reduce these flow hydraulics and scour. Therefore, a layer of the larger rock can be used to partially fill the pool upstream and then the smaller rock can be spread over these. The elevation of the resulting riffle should not exceed the level 0.8 feet lower than the lowest point of the current rock structure cross section. This riffle can extend as far back as the downstream end of the pool at distance 3050 on the profile.

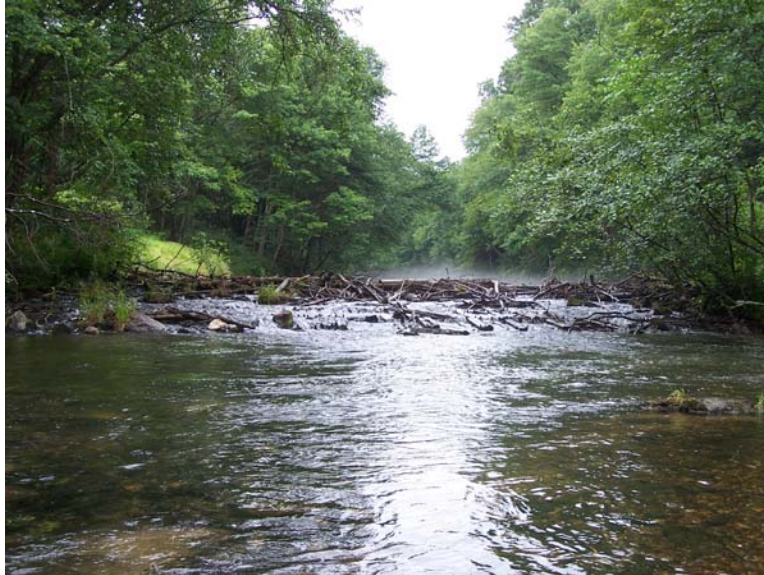
- There is an additional deteriorating dam structure approximately 570 yards downstream of the rock structure that impounds water. Its removal could also improve coldwater habitat upstream of it. The structure does not appear in the state dams database. A local resident said that the structure is a former ice dam.

Photo 6. A deteriorating former ice dam 570 yards downstream of the rock structure.
